Industrial Floor Slabs: Patterns in Manufacture

A study of concrete floor slabs in industrial buildings, recently completed by CCANZ, aimed to identify consistent trends in the manufacture of successful and less successful examples.

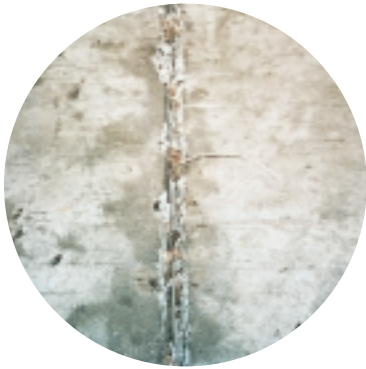
Joint failure. Pallet stackers with solid tyres are causing the epoxy nosing to pull away from the adjacent 25MPa concrete.

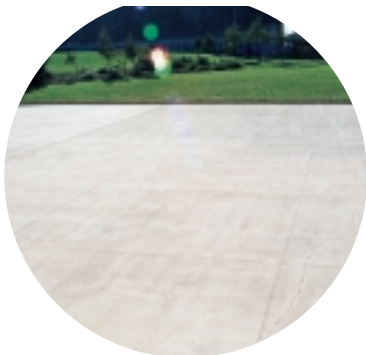
Early thermal shock crack in exterior concrete slab. Note the slab run adjacent to the saw cuts suggesting the crack was present before the saw cutting operation.

1. A high quality concrete floor slab can be achieved with good design and construction technique.
2. Uncontrolled cracking is an issue that needs to be addressed particularly in the Christchurch market. It appears that the most common cause of cracking is restrained early thermal contraction, caused by lowering ambient temperatures during the first few days of the slab's life.

- Understand the importance of early age care, and take precautions to prevent early age restrained thermal contraction. These precautions might involve insulating the slab, the use of crack initiators or early entry saws.

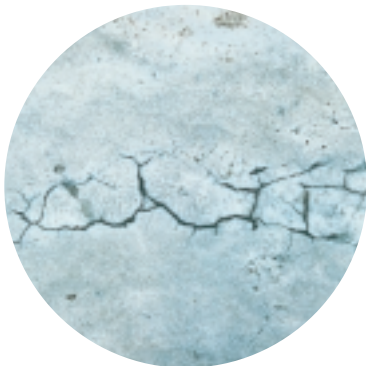
Isolated crazed slab that is delaminating. Possibly lost surface type of delamination refer text for explanation.

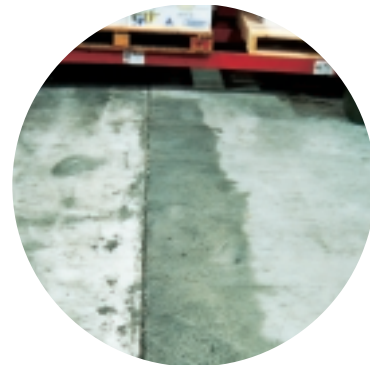
Hand trowelled section adjacent to the construction joint is considerably less durable than the rest of the slab. Bleed water/cement paste may have been mixed at edges.

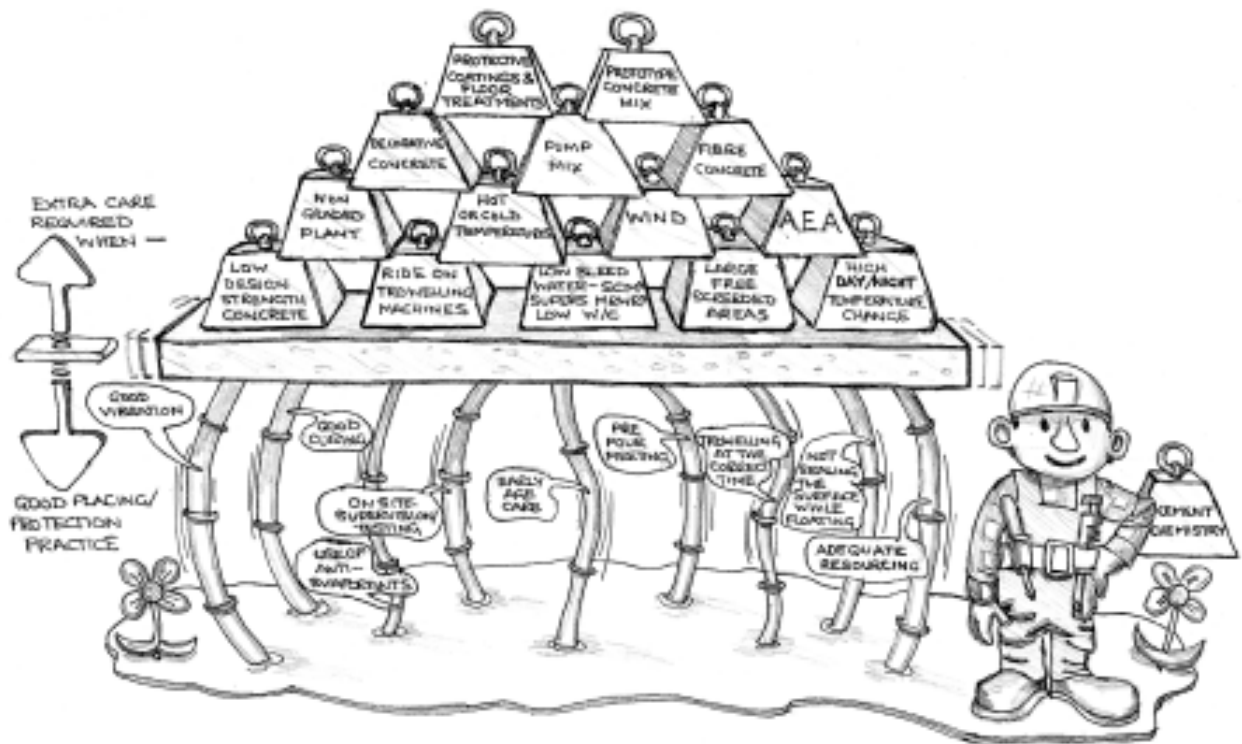
Figure 1 The variables that affect the outcome of the finished quality of a concrete industrial floor slab

The cartoon depicts a slab suspended on shaky poles. If the poles break, the slab falls - this is defined as a failure. A failure for a real slab might be unwanted cracks or a delaminating surface. We can prevent failure of the cartoon slab by making sure that the poles, which represent various placing and finishing practices, are strong enough. The strength of the pole is representative of the quality of the trade practice. Therefore, a strong pole equals good trade practice and a weak one, poor trade practice. The poles only have to be strong enough to support the weight of the slab, to ensure an adequate fit-for-purpose slab. If the weight is low, then a good end result might be achieved with less than perfect workmanship and with some of the less important poles missing. However, when the cartoon slab is heavy, all the poles need to be as strong as possible.

On the top of the cartoon slab are various weights. These represent conditions that impact on the probability of the slab failing. The weights are not necessarily undesirable, and in many instances there are good reasons for adopting them (such as economy and durability), but they do mean that additional care (stronger poles) will be required to ensure a good end result.

A cartoon was developed for the report, to help visualise the variables associated with constructing a fit-for-purpose slab and their interaction. It is not exhaustive, but it does cover the main issues.

The weights are shown as equal size. The reality is that this is not the case. The relative importance of each weight will be project specific, but trying to show them as different sizes overly complicated the cartoon. The message is that those involved in the design and construction of the concrete floor slab must understand the significance of these variables. The report provides an explanation of how each variable affects the properties of concrete, and what additional care is required.

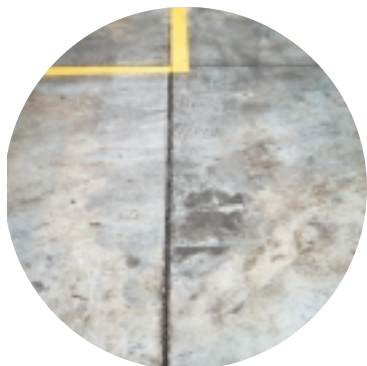
Grinding at slab edge to repair slab curl.

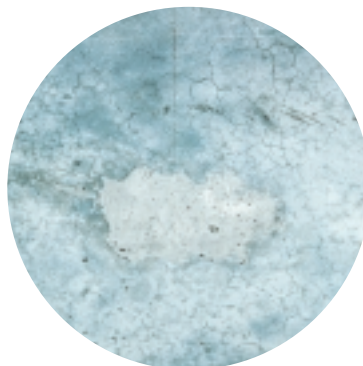
Area of delaminated slab which has been repaired.

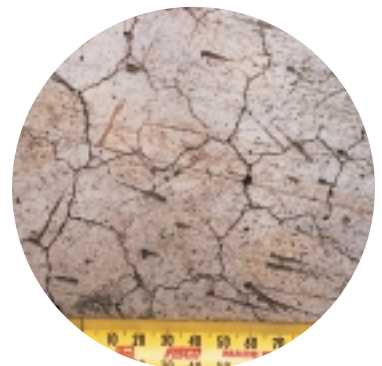
Example of serious crazed cracking.

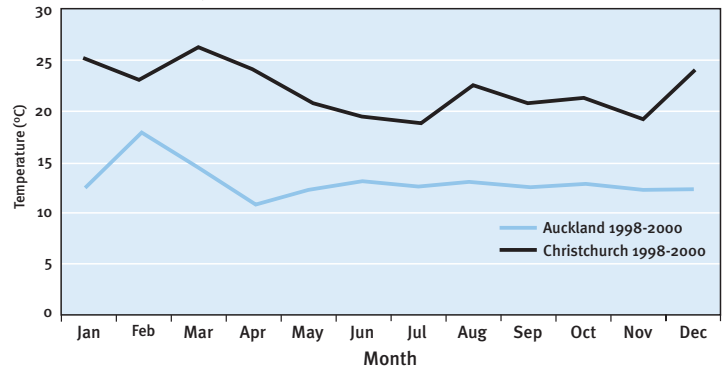
Figure 2 Maximum daily temperature variation (1998-2000) by month for Auckland and Christchurch

The figures show that the maximum daily temperature variation (Figure 2) and the monthly average daily temperature variation (Figure 3) are largest in Christchurch. There appears to have been little research conducted to quantify the critical temperature drop that will cause cracking due to restrained thermal contraction. It is a complex issue as wind chilling, creep characteristic of the concrete, soil temperature, curing technique, and temperature gradients in the concrete are all likely to be important variables. However, a rule of thumb often mentioned is that there is a risk of restrained thermal contraction cracking if the temperature drop exceeds 10 to 15°C in the 24 hours after finishing.

The report suggests that restrained early age thermal cracking is a significant cause of cracking in Christchurch. Figures 2 and 3 provide some explanation why this cracking is more prevalent in Christchurch than Auckland.
