## Paving the way for success

Paving the Olympic precinct

While sporting achievements were naturally the focus of the Sydney Olympic Games, great performances behind the scenes contributed to the success of the event. Homebush Bay, a vast complex created in a disused industrial area, provided the perfect backdrop to the action. In this article, Marc Mearing and Glen Fuller from Rocla Pavers & Masonry, and Sam Harb, 'Sam the Paving Man', detail the development of the segmental concrete interlocking pavers used across 160,000m<sup>2</sup> of Olympic precinct.

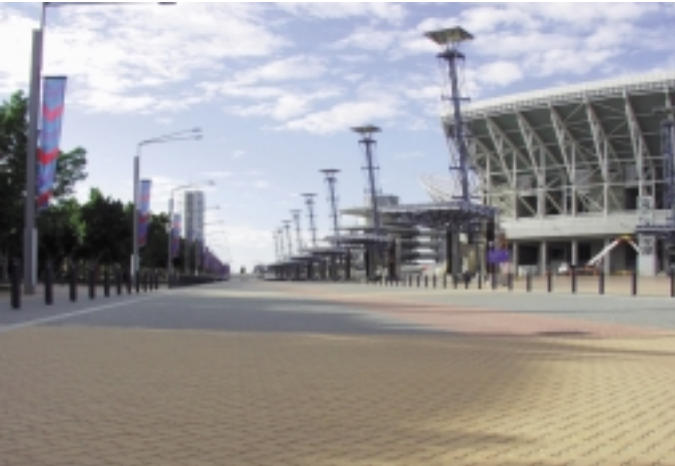
- The base course for the pavement was a heavily bound crushed rock. Base levels had to be  $\pm 5\text{mm}$  over 3 lineal metres. Purpose designed undulations and crowns in the plazas' pavements were not allowed to be joint-line ridged or 'valleyed'. Final levels were cut immediately after forming the base course.
- Bedding material under the ecological pavers was a single sized 5mm crushed rock. This required special screeding techniques as it did not compact in the same manner as traditional bedding sand: a circular technique with a bed plate vibrator was required to overcome rutting. The 5mm aggregate for the ecological paver drainage holes was swept in with a 2.5 metre broom mounted on an all-terrain forklift.
- No kerb and channel was used at the boundary of the boulevard as no demarcation line between boulevard and plaza exists. This meant that paving joint lines extended for 300

metres across the plazas and up to 1.5 kilometres along the boulevard. Joint lines had to be straight to achieve the defined layout. Paver sizing, particularly spacer nib sizing, was critical to achieving this.

- The 'carpet' effect meant machine laying (which left cluster lines throughout the pavement) was not allowed. All pavers were laid by hand; leading up to key opening dates, up to 50 pavers were operating on the project 24 hours a day.
- Final profiles at paver colour intersections could not be cut in once laid. A purpose designed intersection piece had to be hand cut to ensure it was the major portion of a paver. This required approximately 10 diamond brick saws on site at all times.
- Inspection and acceptance of paved areas was mandatory prior to final sanding and tamping. Unacceptable pavers and areas were sprayed in iridescent paint and removed before proceeding to final joint filling and compaction.
