Slipforming On Route PJK

Following a specification change by Transit NZ, contractor **Smithbridge** proposed slipforming as the most appropriate solution for median barrier construction on a section of highway on the outskirts of Tauranga.

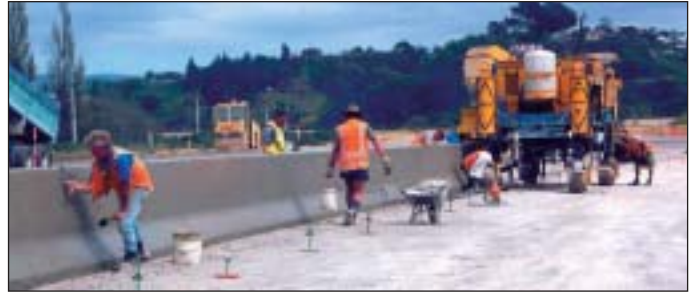
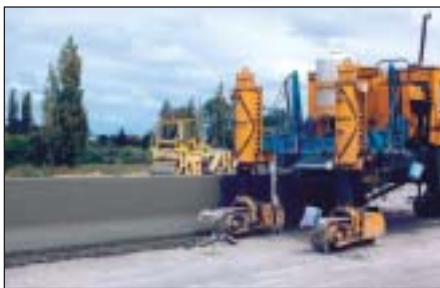
During operation, the median barrier mould is mounted solidly to the Gomaco frame, with the height and orientation of both adjusted by hydraulic legs that connect the tracks to the frame. Control is provided by a microprocessor with sensors on a string line, at points before and after the mould.
